Manhole Inspection Summary

Manhole # S65O__006MH

Location Address: **1235 Anglesea St.**

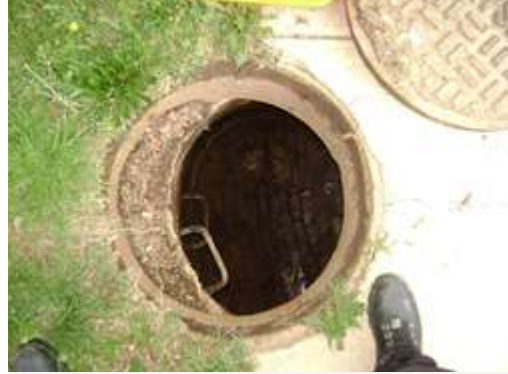
Top View

difficult to see channel because it looks like this was a terminal manhole that had an incoming (service line) pipe added

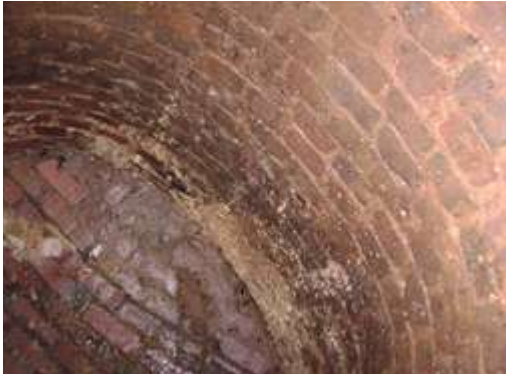
Defect 4

Infiltration: ☐ None ☒ **Joint** ☐ Cracks ☒ **Mortar** ☐ Roots ☐ Wall

evidence of infiltration where barrel wall meets bench

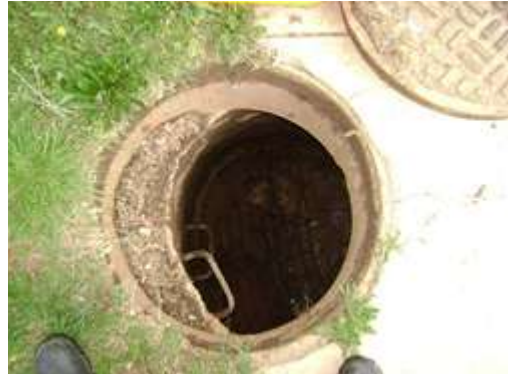
Defect 1

Offset: **4** (in.)

frame offset

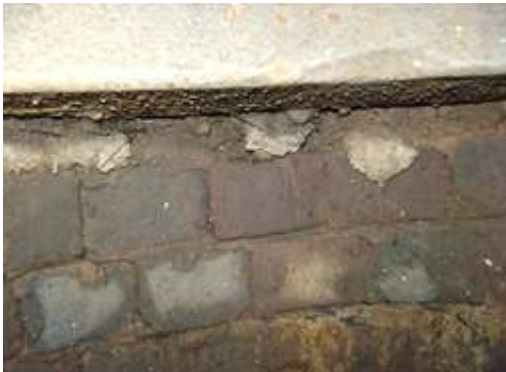
Defect 2

Infiltration: ☐ None ☒ **Joint** ☐ Cracks ☒ **Mortar** ☐ Roots ☐ Wall

infiltration under frame

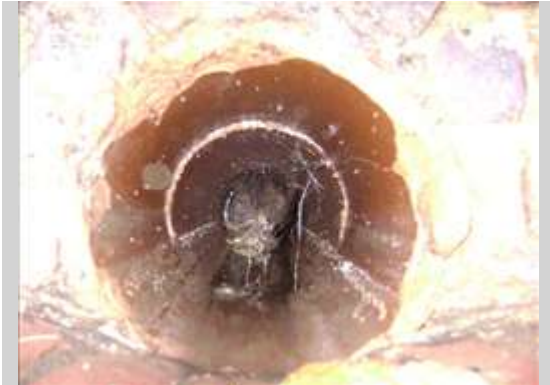
12 O'Clock Outflow

8 in. Circular Gravity Sewer
Pipe Out @ 12 O'Clock

Pipe Height: **8.4** (in.) Rod and Bar (Angled)
Pipe Material: **Clay** ☐ Pipe Lined
Invert Depth: **6.50** (ft.) Flow Characteristics: **Slow**
Deposits: ☐ None ☐ Mud ☐ ~~Gravy~~ ☒ **Debris** ☐ Grease
Silt Depth: **3** (in.) Deposits Extent: **Medium**
Infiltration: **None** Pipe Seal Cond: **Sound**

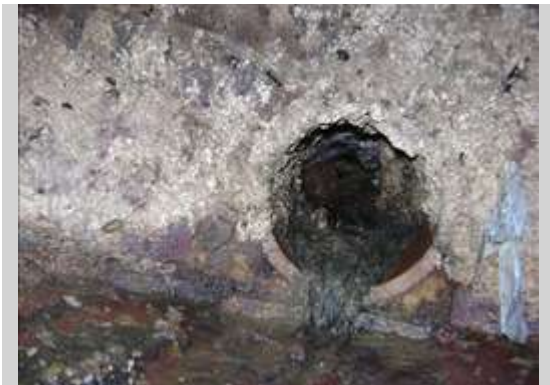
6 O'Clock Inflow

6 in. Circular Gravity Sewer
Pipe In @ 6 O'Clock

Pipe Height: **6** (in.) Rod and Bar (Angled)
Pipe Material: **Clay** ☐ Pipe Lined
Invert Depth: **6.00** (ft.) Flow Characteristics: **Slow**
Deposits: ☐ None ☐ Mud ☒ ~~Gravy~~ ☒ **Debris** ☐ Grease
Silt Depth: **2** (in.) Deposits Extent: **Medium**
Infiltration: **None** Pipe Seal Cond: **Sound**
